**Final
Technical Memorandum**

**SH 121/Main Street (FM 423) and SH 121/Paige Road Traffic Study
The Colony, Texas**

City of The Colony

August 31, 2010

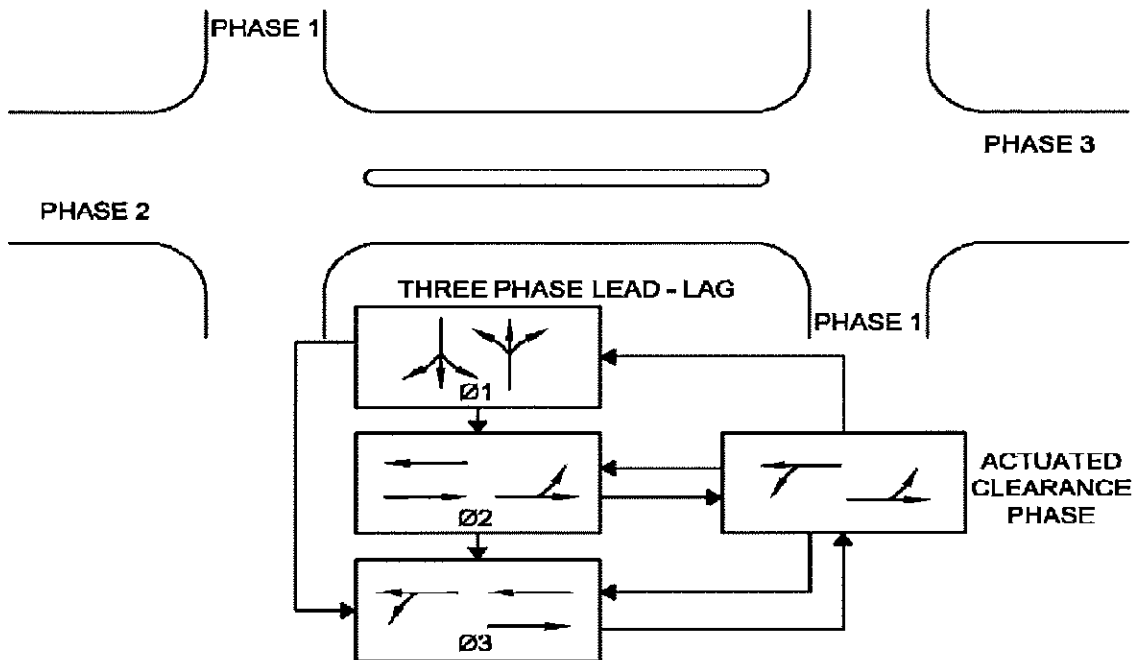
A 3-phase lead-lag operation in which traffic on both ramp approaches begins simultaneously (Phase 1). Phase 2 follows Phase 3 if there is a demand (detector activation) for the phase. Phase 3 follows Phase 2 if there is a demand for the phase, and Phase 1 follows Phase 3 if there is a demand for that phase. This phase sequence is shown in **Figure 9**.

Figure 9: 3 - Phase Lead - Lag Sequence

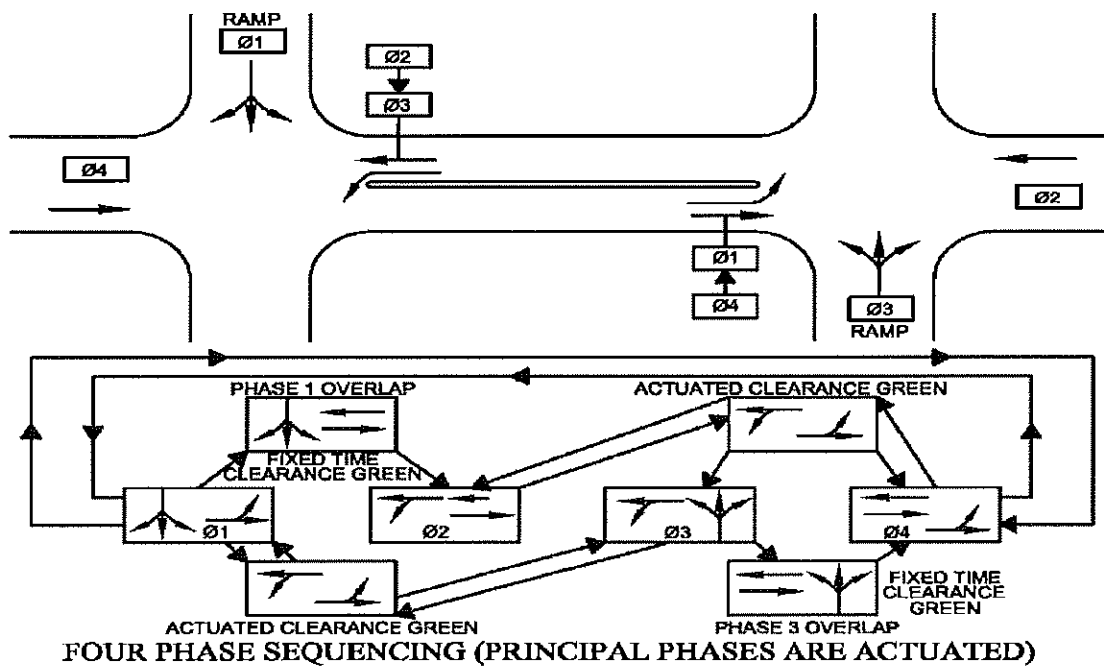
A 4-phase operation with 2 overlaps, in which traffic on one of the ramp approaches is released simultaneously with thru and left-turn traffic (on the intersecting arterial) at the other ramp intersection, thereby clearing any possible internal queue for the traffic turning left from the ramp (Phase 1). From Phase 1, the controller unit moves to Phase 1 overlap, in which the opposing traffic on the arterial (at the, as yet, unserved ramp intersection) is released while the ramp approach green continues. The Phase 1 overlap phase must be of fixed time duration since the running ramp green must be terminated to accommodate the progressive movement of the arterial traffic released at the start of the overlap phase. This fixed time period is determined by the travel time of accelerating arterial traffic from a stop at one ramp intersection, and through the other ramp intersection. The controller unit proceeds then to Phase 2 green to accommodate the above described approaching arterial traffic (thru and left-turns). For Phase 3 initiation, traffic on the arterial (at the, as yet, unserved ramp) is cleared and terminated for release of traffic on the ramp approach. As the diagram shows, flow continues to Phase 3 overlap and on to Phase 4, serving remaining traffic movements. This phase sequence is shown in **Figure 10**.

Figure 10: TTI 4 - Phase Sequence
